City of Neligh, NE
Blight and Substandard Study
January 2014

PURPOSE OF THE BLIGHT AND SUBSTANDARD STUDY

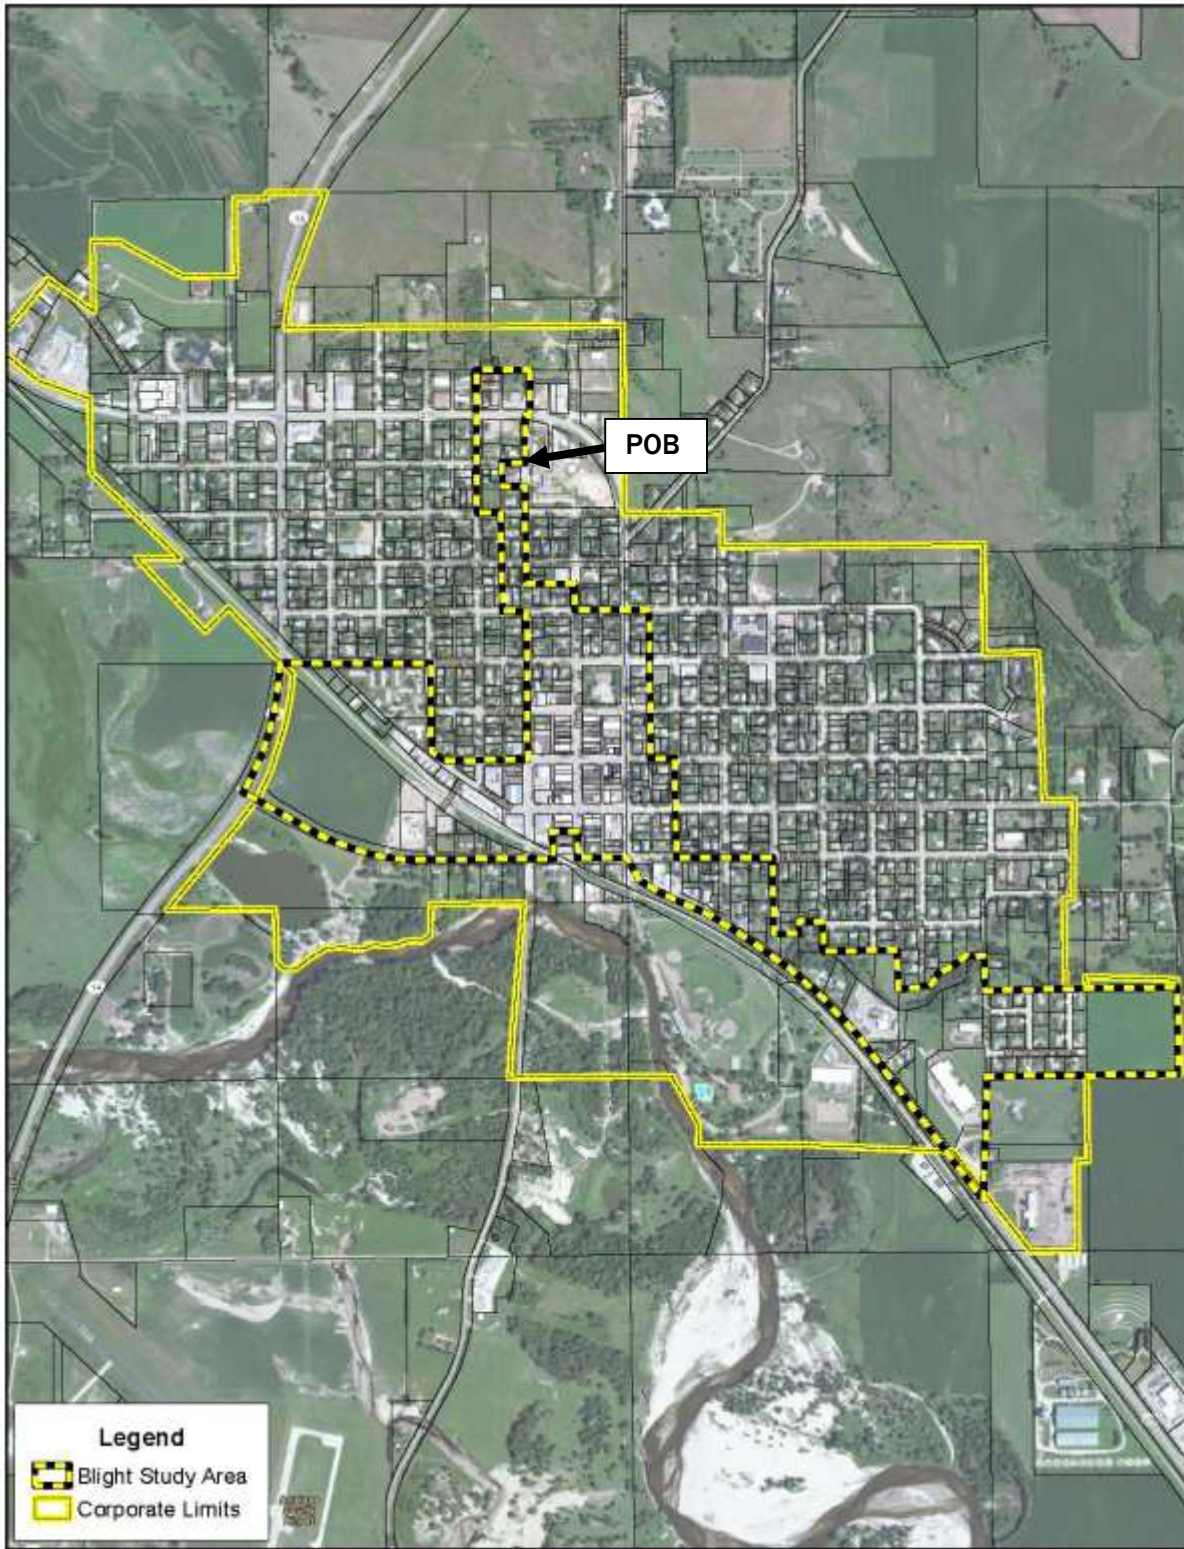
Figure 1
Study Area Map

The study area can be seen in Figure 1 of this report. The Redevelopment Plan portion of this report will contain, in accordance with the law, definite local objectives regarding appropriate land uses, improved traffic, public transportation, public utilities and other public improvements, and the proposed land uses and building requirements in the redevelopment area and shall include:

This study targets a specific area within an established part of the community for evaluation. The area is indicated in Figure 1 of this report. The existing uses in this area include residential, commercial, commercial/office, public and industrial.

The total area in the blight and substandard are is 165.52 acres. At present the total area within the corporate limits of Neligh is 733.76 acres; therefore the area within the blight and substandard area equals 22.6%, well within the statutory limitation of 50.0%.

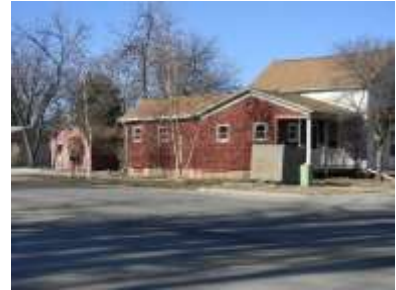
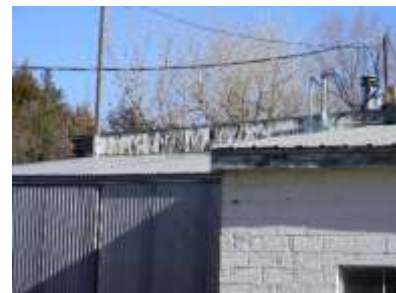
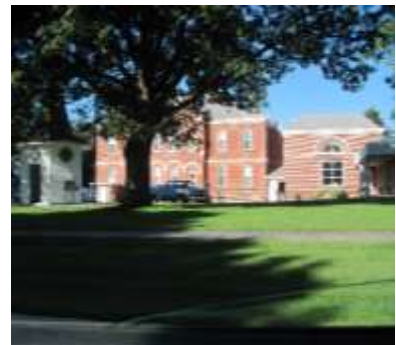
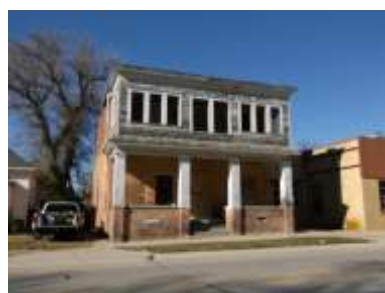
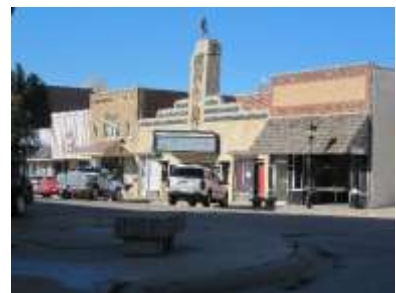
- 184 (81.1%) units were determined to be 40 years of age or older
- 43 (18.9%) were newer than 40 years.

Based upon this data, the age of the structures is a direct contributing factor.

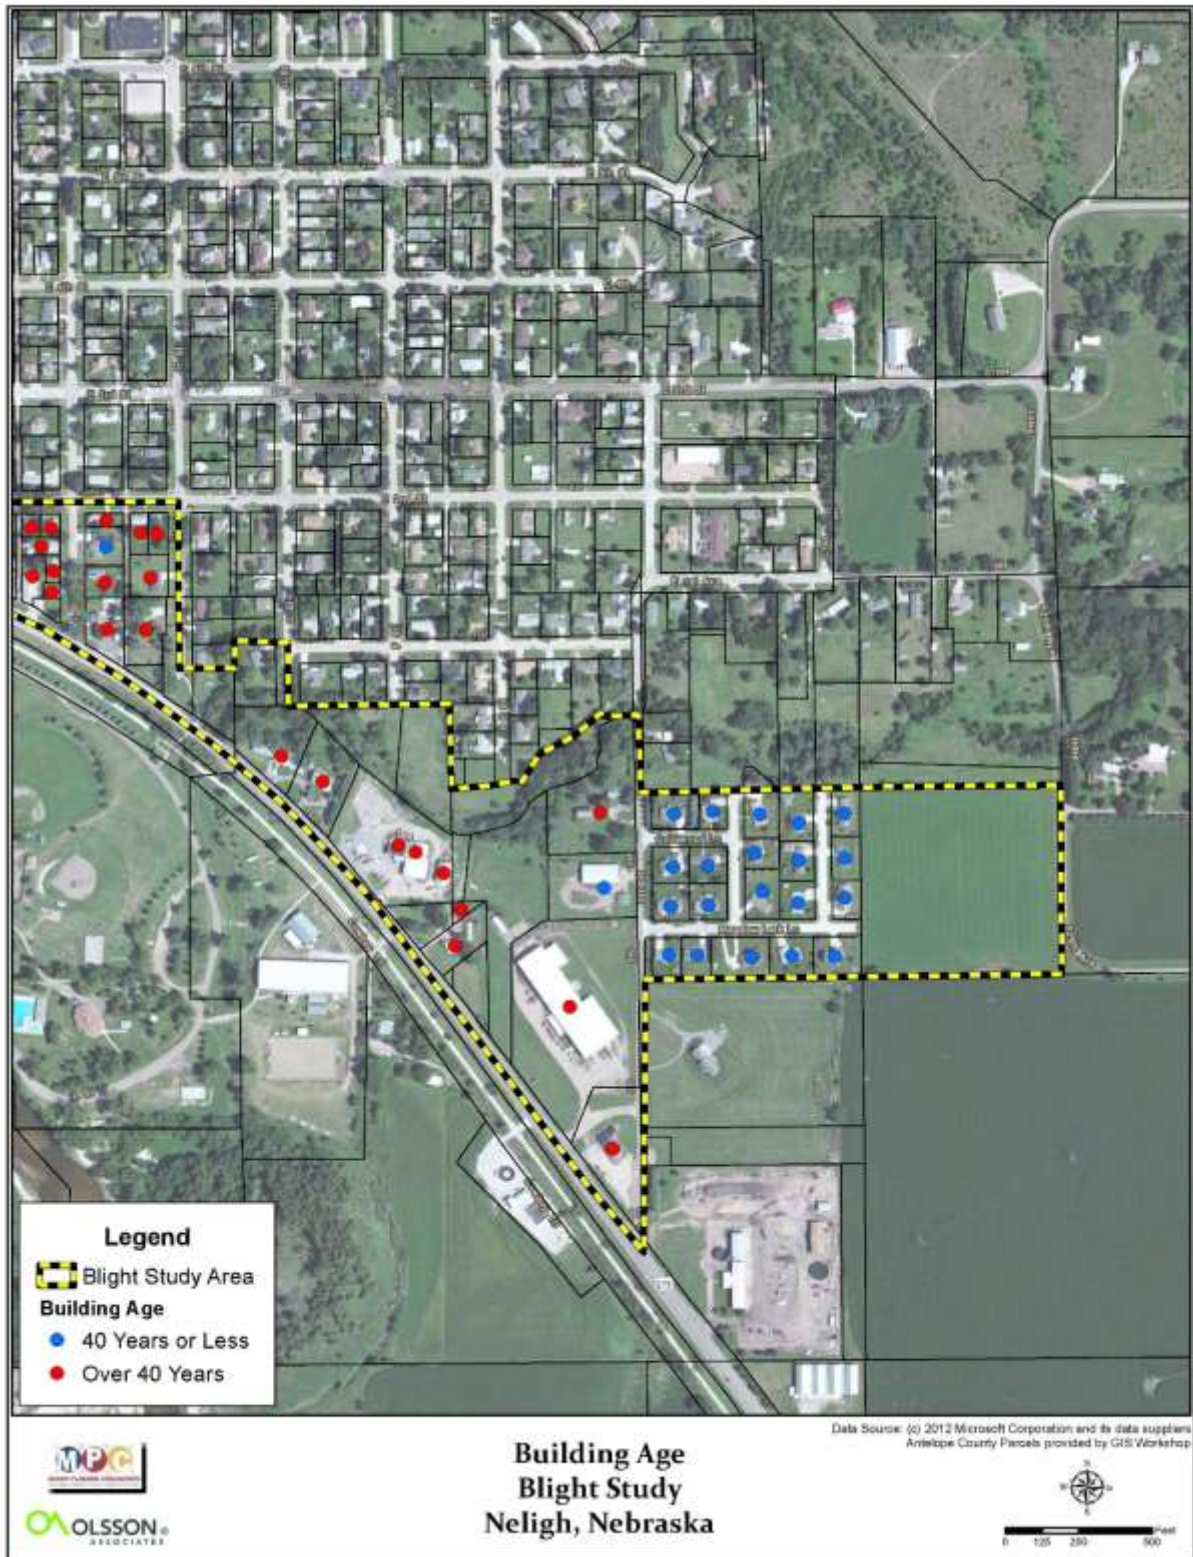
Figure 3A
Unit Age Map

Within the study area there is a total of 227 structures. After researching the structural age on the Antelope County Assessor's and Treasurer's websites, the following breakdown was determined:

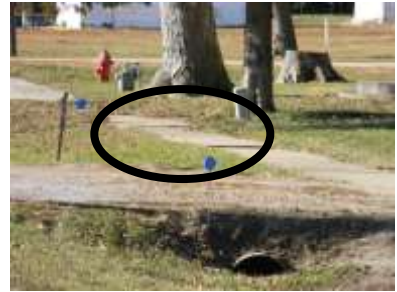
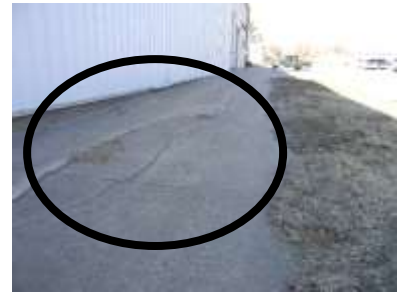
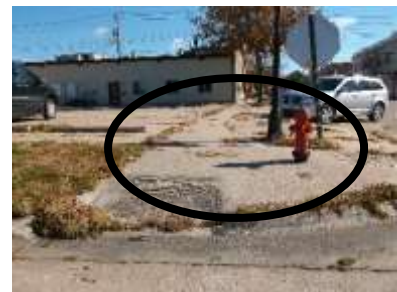
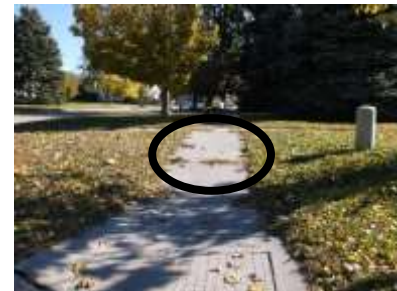
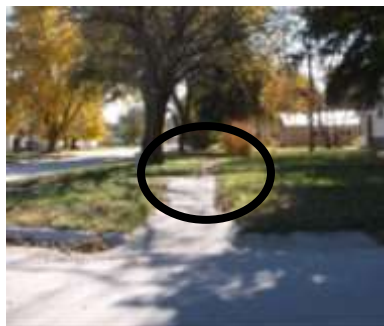
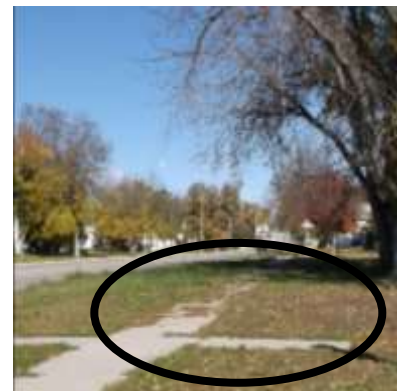
Deteriorating is defined as any vertical heaving, concrete break up, and spawling of the walking surface.

Overall, there is over 85% of the area that either has deteriorating or no sidewalk to allow for safe pedestrian movement. There is no sidewalk present in over 55% of the study area does not have safe accessibility to pedestrian traffic.

Due to the large amount of missing sidewalk, the lack of and condition of the sidewalk is a direct contributing factor.

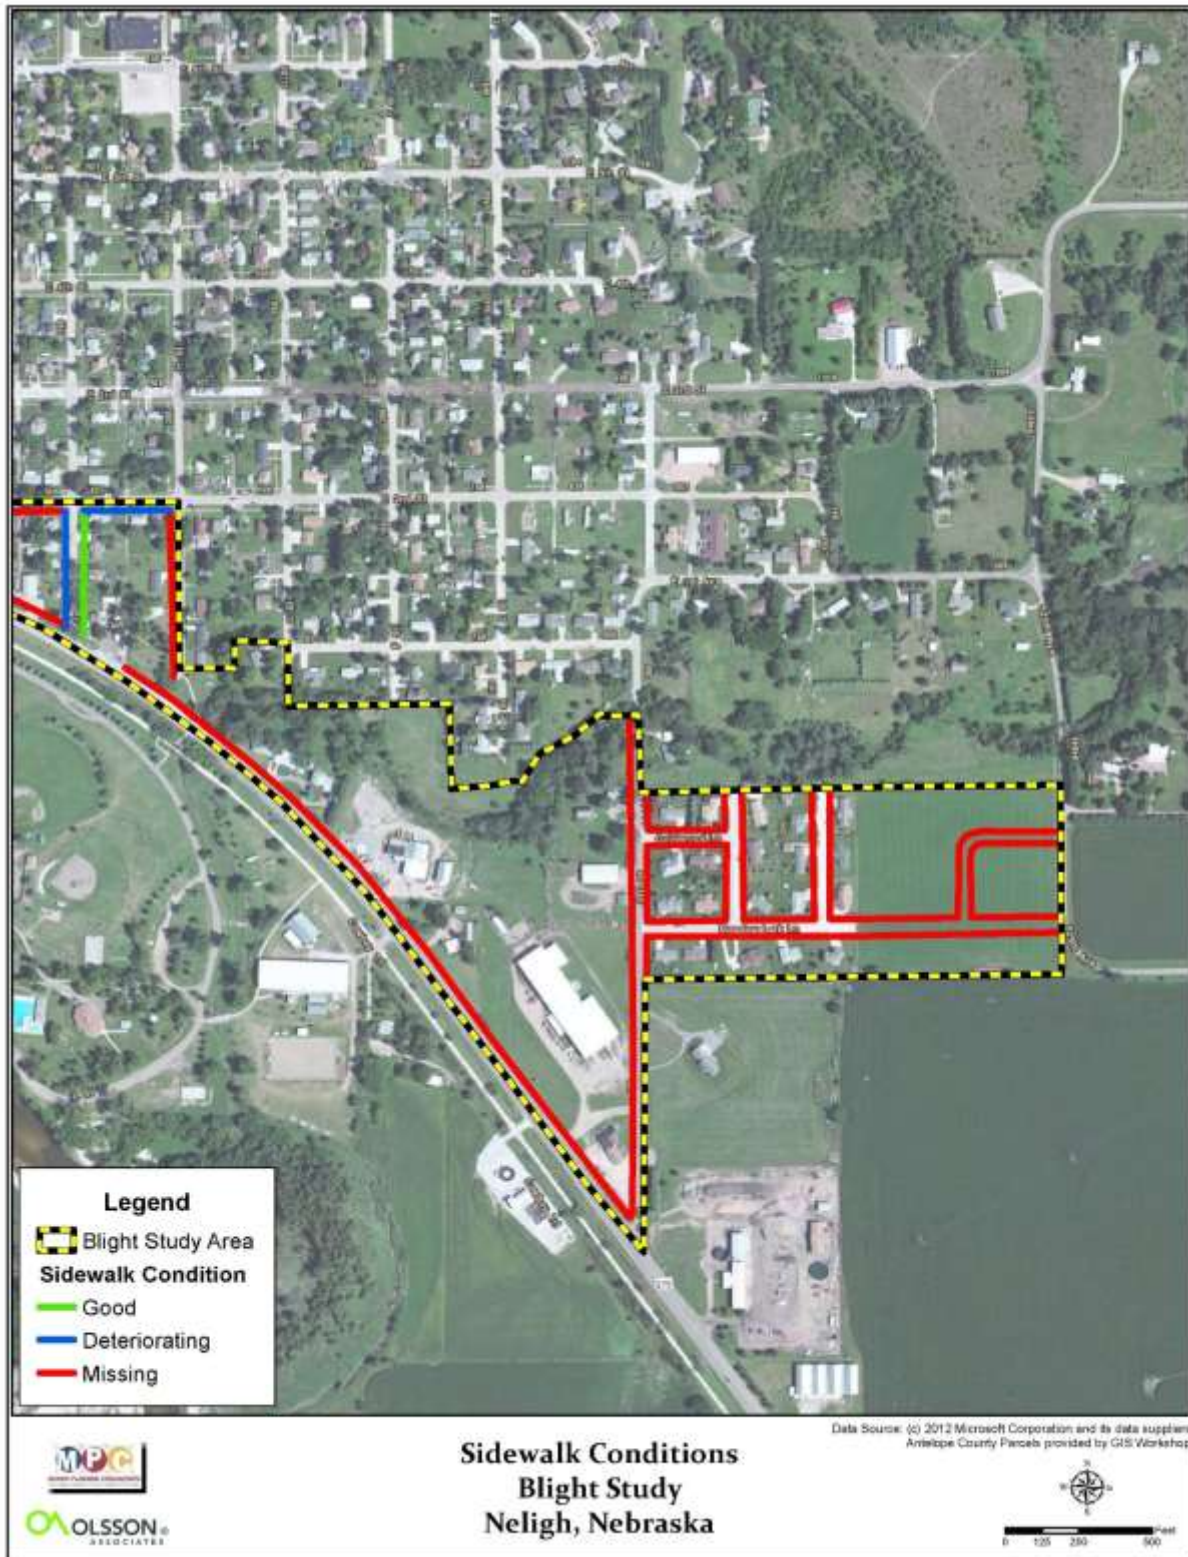
Figure 4A
Sidewalk Conditions

- 5,621 (13.8%) lineal feet of adequate sidewalk
- 12,568 (30.9%) lineal feet of deteriorating sidewalk
- 22,416 (55.3%) lineal feet of no sidewalk.

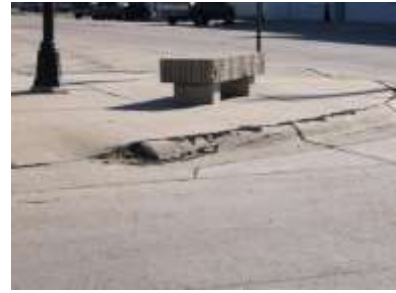
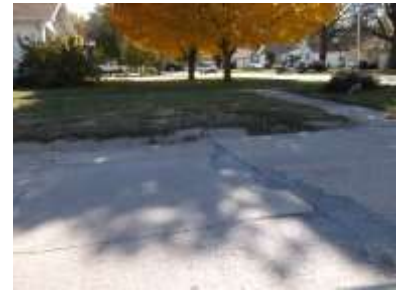
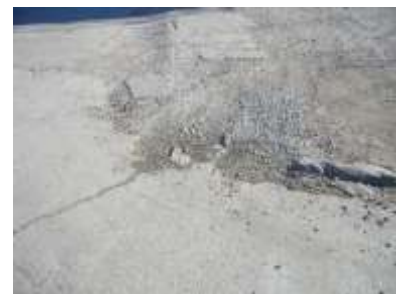
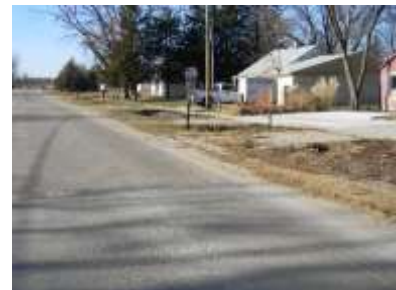
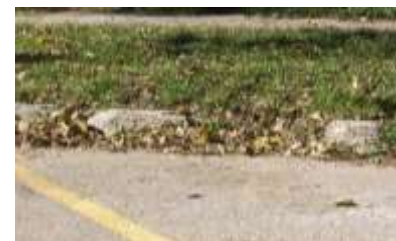
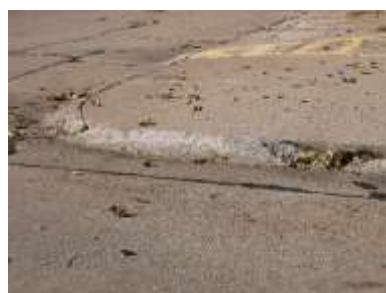
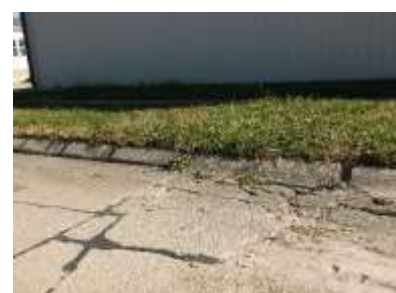
Deteriorating is defined as any evidence of breakage/chipping away at joints and horizontal surfaces. In addition, any heaving or breakage along the gutter portion of the system.

The photos to the immediate right show some of the deteriorating conditions found within the study area.

Due to the large amount of deteriorating and missing curb and gutter, the curb and gutter condition would be a direct contributing factor.

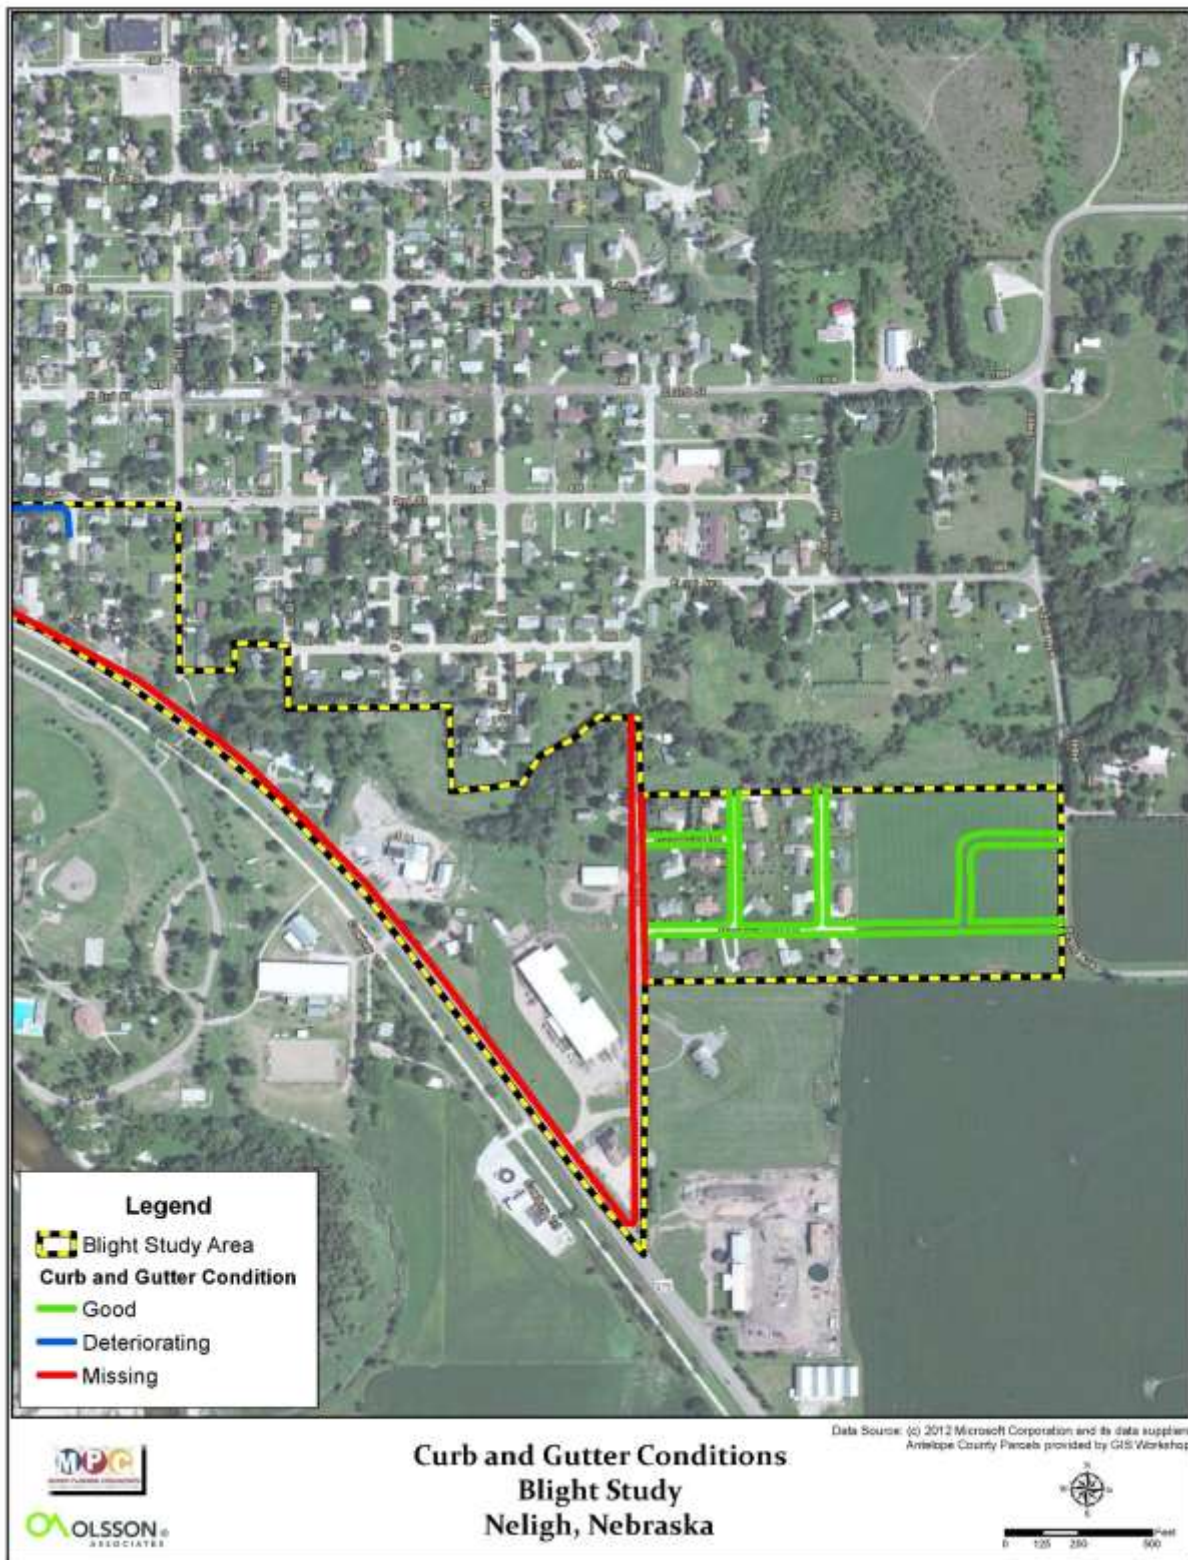
Figure 5A
Curb and Gutter Conditions

- 13,460 (32.4%) lineal feet of adequate curb and gutter
- 15,500 (37.3%) lineal feet of deteriorating curb and gutter
- 12,630 (30.3%) lineal feet of no curb and gutter or rural section.

The study area has 67.6% of the curb and gutters in either a deteriorating state or not constructed and the streets are designed as rural section streets. See Figures 5A and 5B for the locations of these curb and gutter.

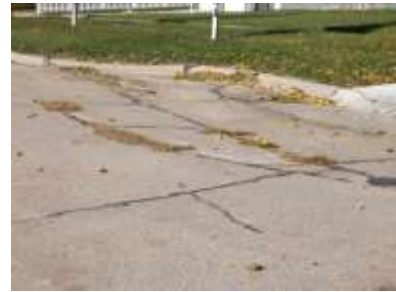
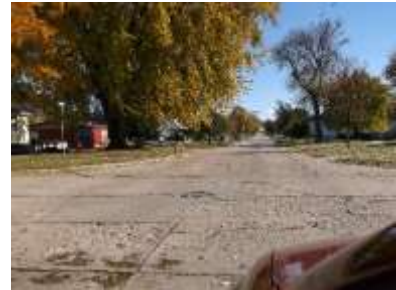
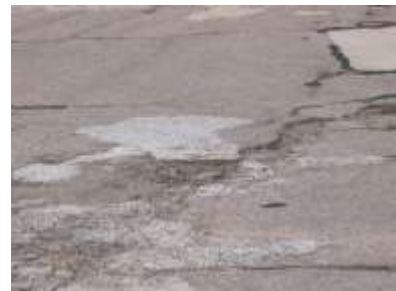
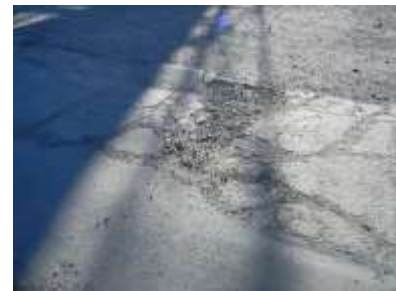
Deteriorating is defined as any evidence of breakage/chipping, heaving, major potholes, spawling finished surface, and materials lose at joints.

The photos to the immediate right shows some of the deteriorating conditions found within the study area.

Due to the large amount of deteriorating or gravel surfacing, the street conditions are a direct contributing factor.

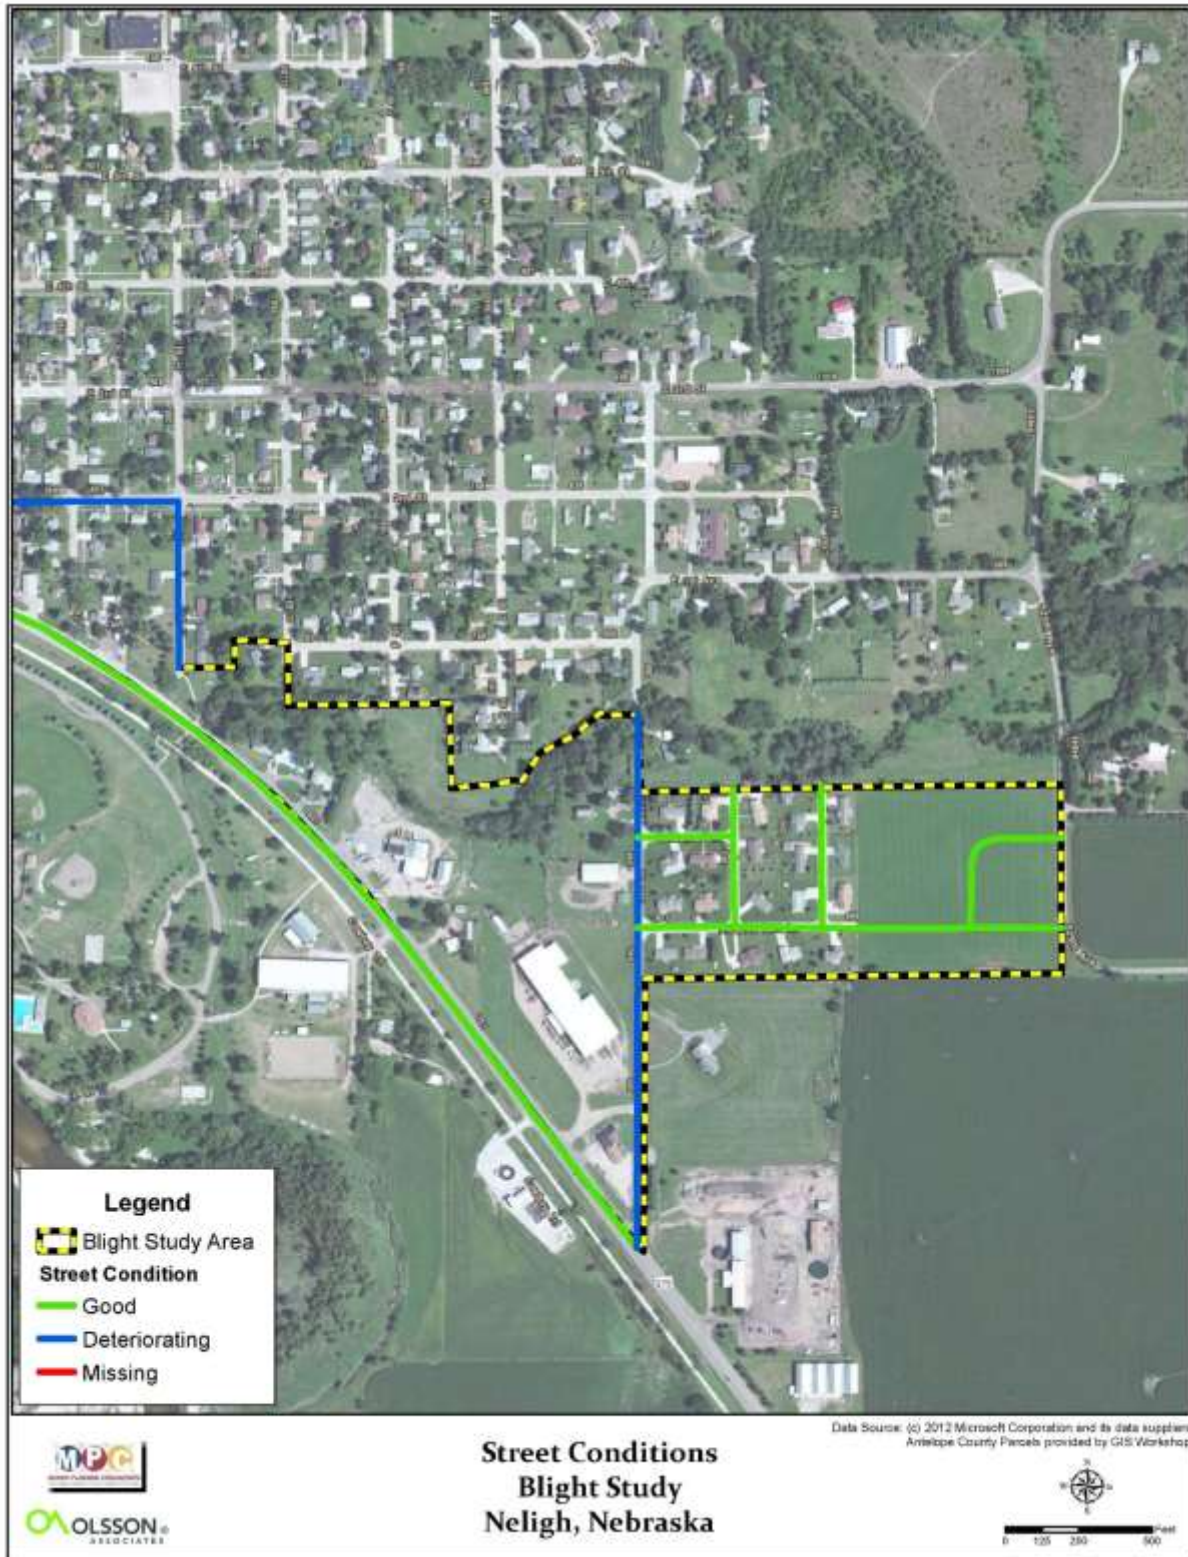
Figure 6A
Street Conditions

- 13,340 (43.0%) lineal feet of adequate street
- 16,130 (52.0%) lineal feet of deteriorating street
- 1,590 (5.0%) lineal feet of gravel street.

The study area has 57.0% of the streets are in either a deteriorating state or they are surfaced with gravel or dirt. See Figures 6A and 6B for the locations of these streets.

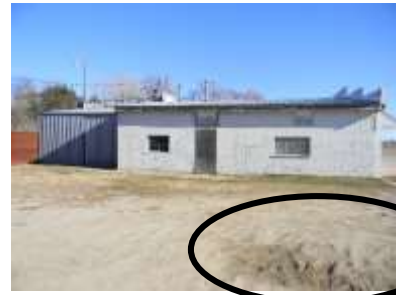
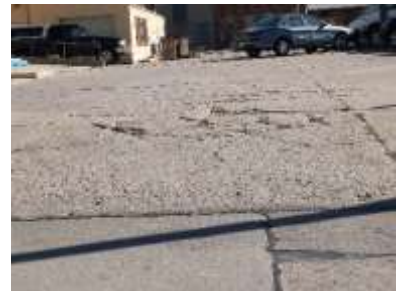
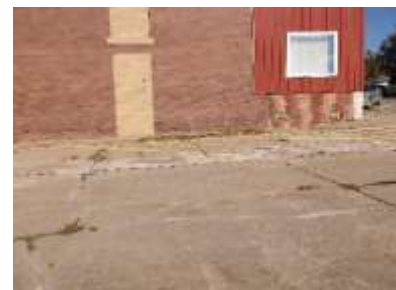
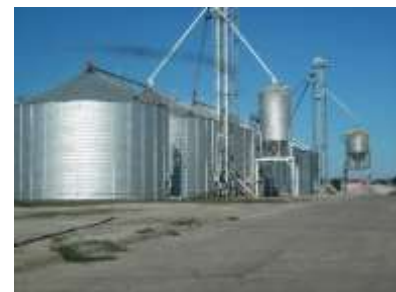
A large portion of the properties have gravel/dirt drives and parking lots. These properties create several issues within a community including:

- Dust conditions during dry periods
- Ruts from heavy equipment
- Water holes during wet periods

Some properties have paved/improved parking areas and drives were found to be in a state of deterioration. Several of the hard surfaced lots, as seen on the right are in considerably poor condition.

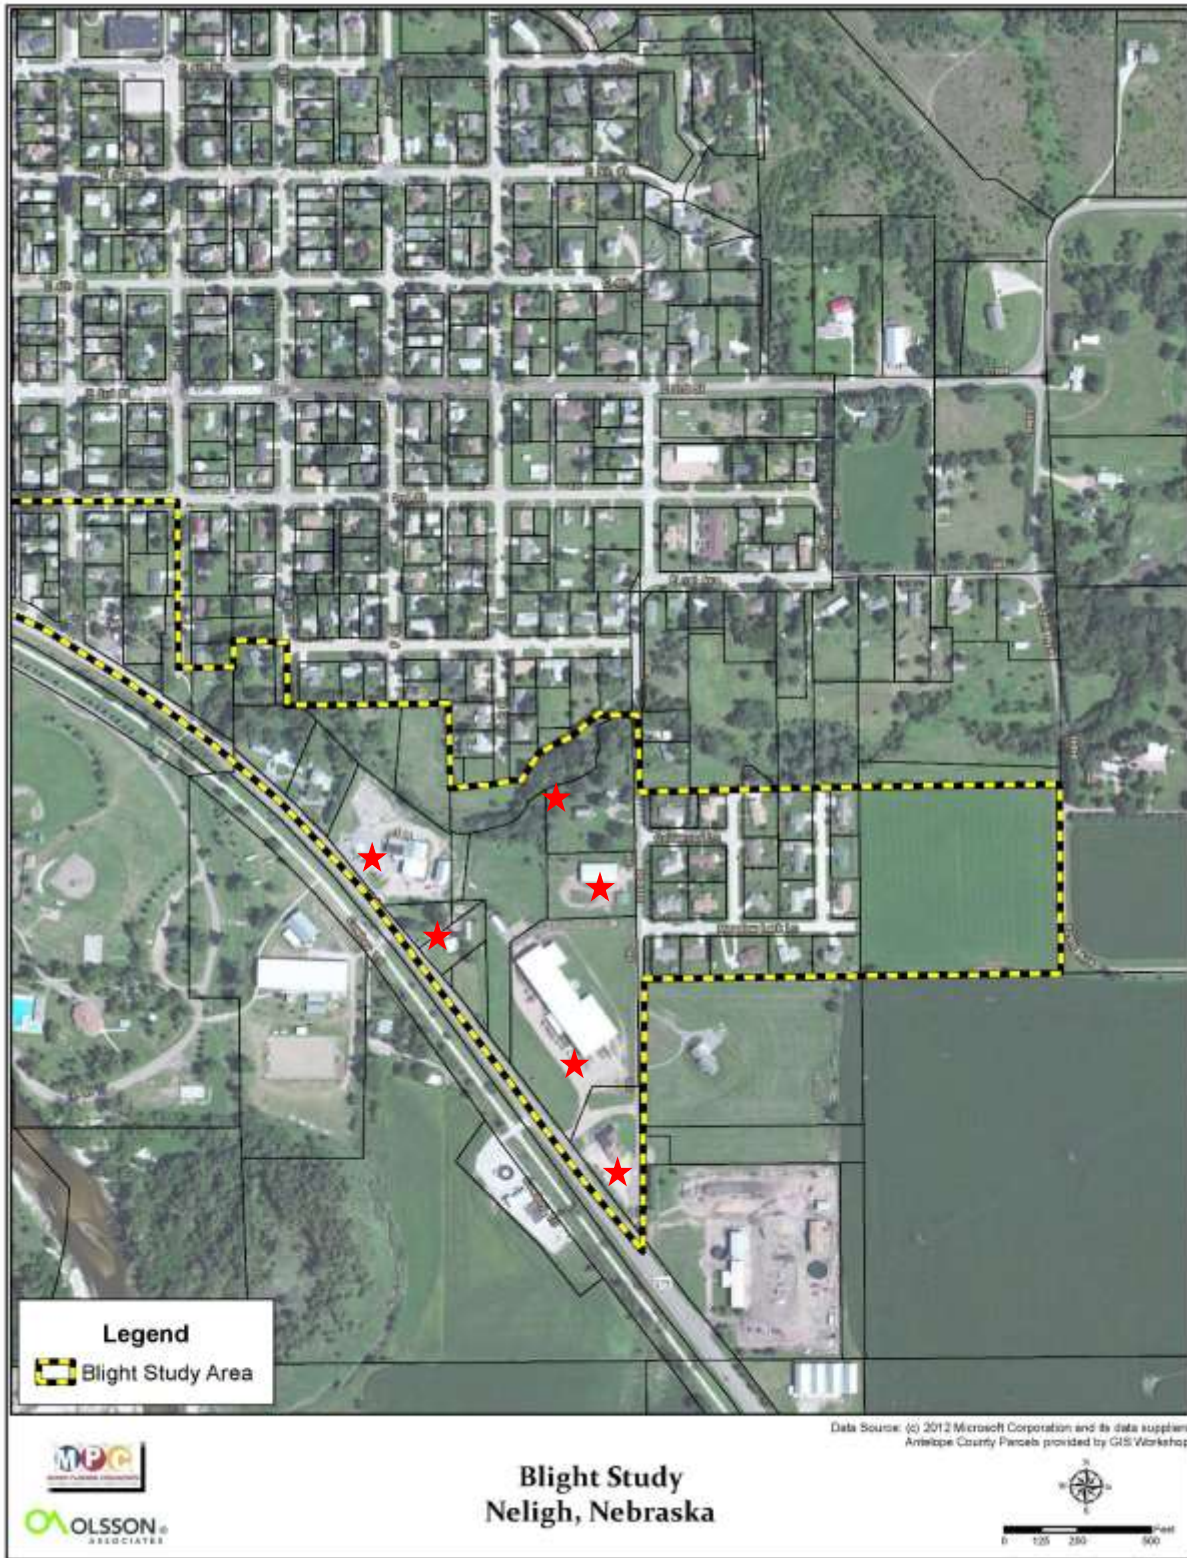
Figure 7A
Site Improvement Conditions

Figures 7A and 7B identify the different properties in the study area that have deteriorating parking areas and drives, as well as those properties that have been hard surfaced and are showing signs of deteriorating and in need of repair/rehabilitation. Even though most of the land uses in this area are heavier commercial to industrial uses, the lack of hard surfacing or the deterioration of the existing hard surfacing has a major impact on the perception of the area as well as the value of the area.

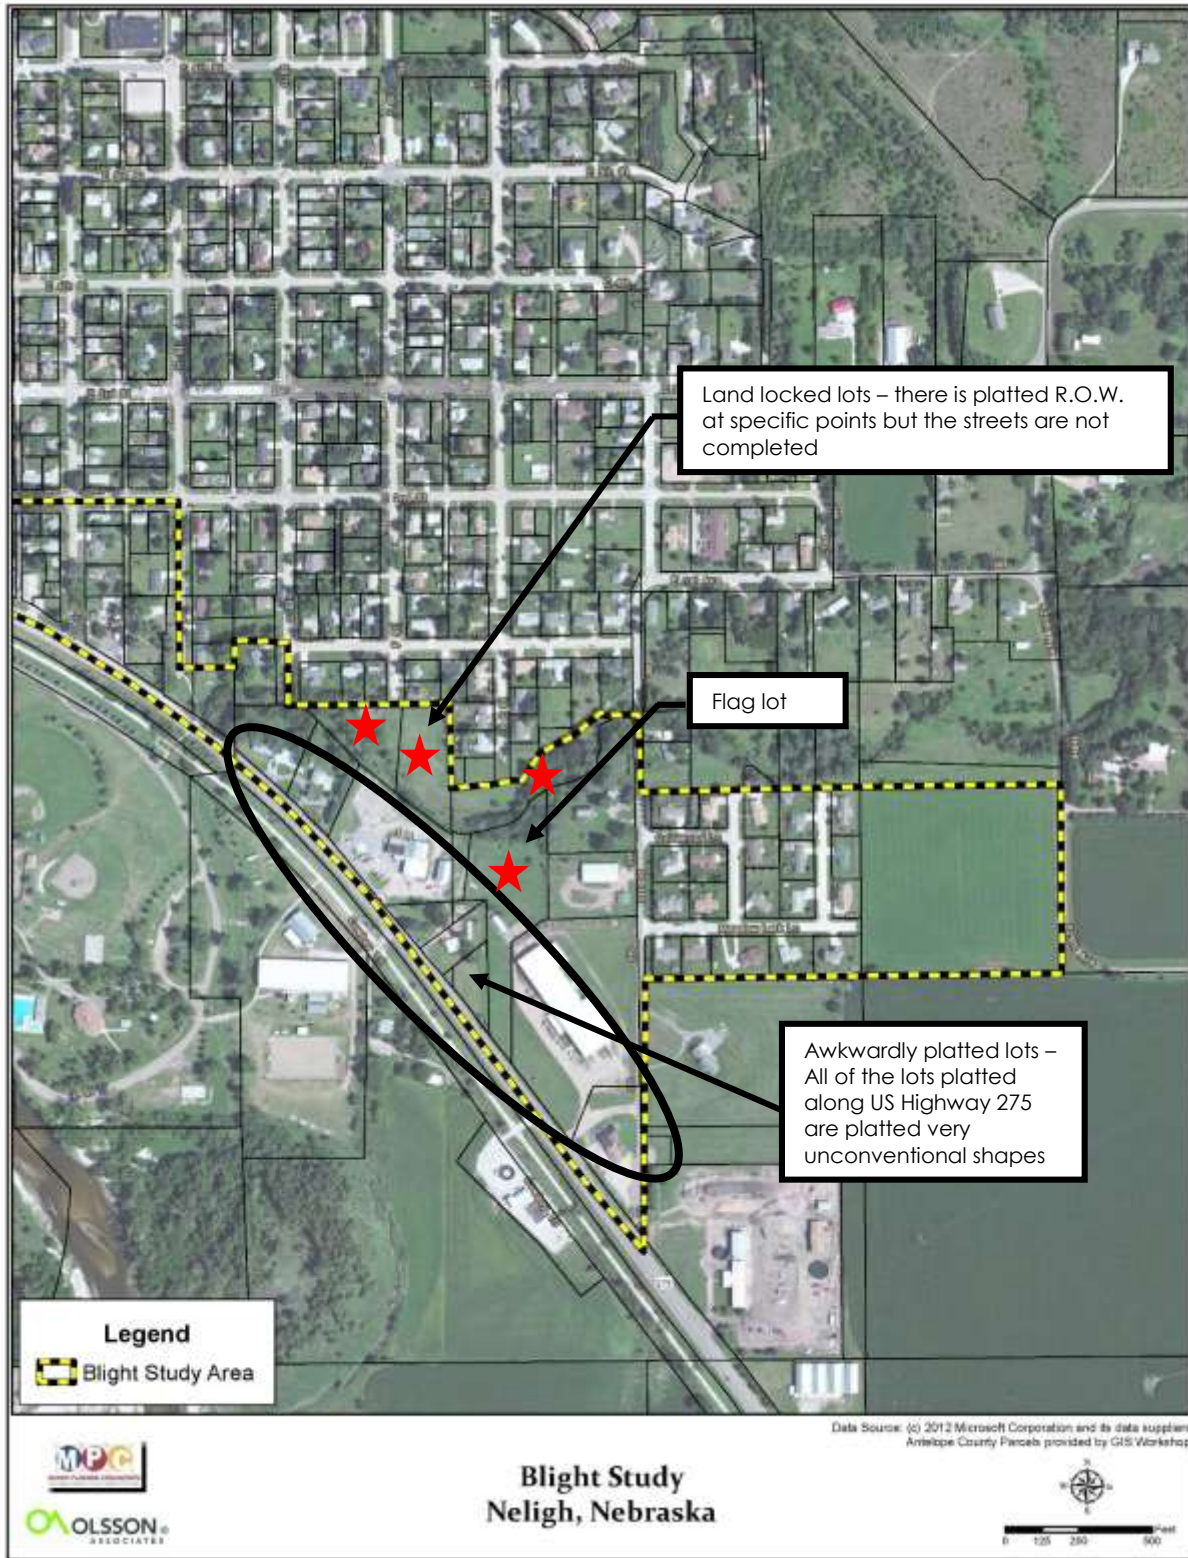
Figure 8A
Faulty Lot Layout Conditions

Accessibility of some lots in the southern portion of the study is impossible without crossing another lot/tract of ground. The lots are land locked and without direct access to any public street.

This criteria is present along the southern edge of the study area along US Highway 275 and along the Cowboy Trail. These conditions can be seen in Figures 8A and 8B.

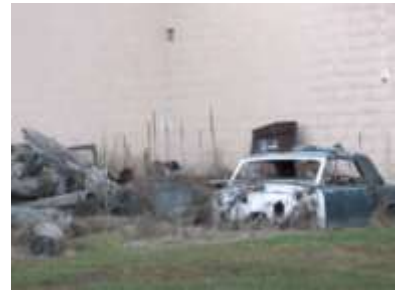
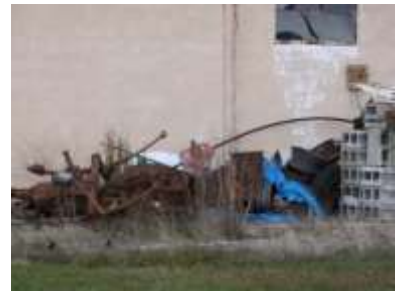
There are locations where property owners have junk and/or junk vehicles located on their property within the study area.

The most specific location for this condition is shown at the right. In one case, the property owner has some of the junk and junk vehicles without any security around the items. In addition to people being capable of directly access these vehicles and materials these conditions are also very attractive places for vermin to congregate.

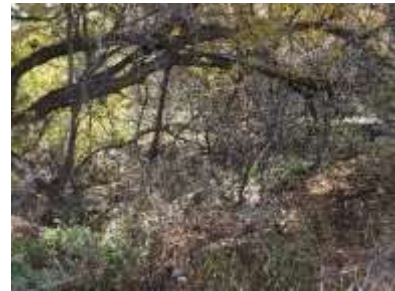
The southern portion of the study area is in close proximity to the Elkhorn River. The lower portions of the study area have been known to be under water.

In addition, the study area contains a drainageway that is in need of being cleaned. The current condition of the drainageway is overgrown and any hard rain similar to a 10-year event or greater could create potential flooding on property immediately adjacent.

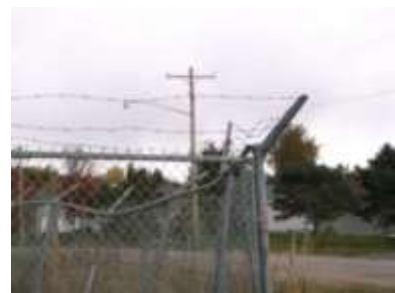
There are a couple of locations on the south side of the study area where barbed wire fencing is in place. Granted this is a necessary situation depending upon the business. However, it does create a situation that is unsafe under the wrong conditions. Barbed wire is specifically harmful when it is not being properly maintained, as is the case in one location within the study area.
